# SLATE ROOFS

## AVOID THESE 21 CONTRACTOR ERRORS

Joseph Jenkins

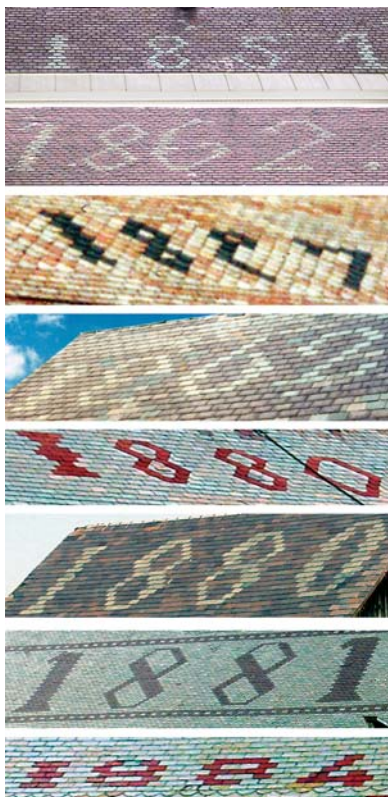
Figure 1: These photos of existing slate roofs attest to the durability, beauty, and longevity of this natural roofing system.

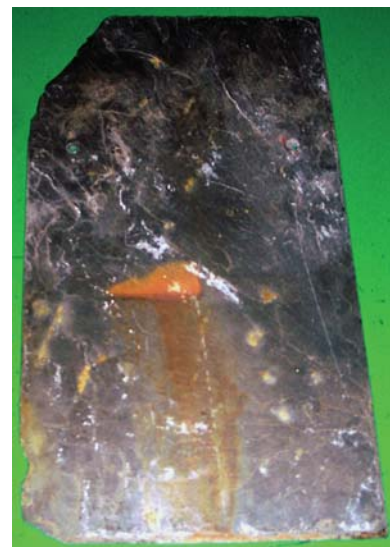
Figure 2: This Spanish black slate leached rust stains down the new slate roof after only one year.

Some Spanish black slates are known for their pyrite content, which will bleed red rust stains down the roof. Figure 2 shows such a slate taken off a residence in Florida after only one year on the roof. This large residential roof had to be completely reslated, again at great expense. The owner of the residence selected this slate because he liked the shade of black, not understanding that some slates can change in appearance with exposure to weather. When selecting Spanish slates, it is important to know whether those being considered are pyrite-bearing, a condition that may or may not be obvious by visual inspection. In a recent case on the east coast, an entire church roof had to be reslated because the new Spanish black slates were bleeding rust down the roof and the church people did not like the way it looked. Again, this is not to be construed as a condemnation of all Spanish black slates, as some are quite good.

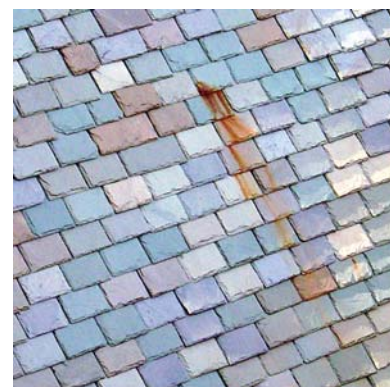
Figure 3: Even domestic slates can rust. These Vermont slates on a high-rise apartment were poor in quality and should have been screened for pyrite inclusions.

**4) CULL OUT BAD SLATES:** Poor quality slates can originate from any quarry. This may be due to the manufacturer not culling out rejects, for example. Shoddy quality control can lead to rusting pyrites on even the best American slates. Figure 3 shows Vermont slates badly rusting down an apartment building roof. This is unusual and indicates a commercial source of roofing slate that should have been avoided, or a bargain slate that wasn't worth the money, and/or a contractor who should have culled the defective slates out, but didn't know what a bad slate looked like.

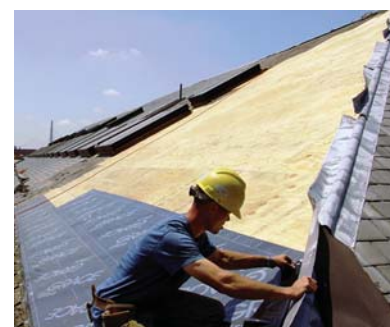
Figure 4: Traditional slate roofing systems, despite their incredibly successful performance, are being largely abandoned in favor of plywood roofs with peel and stick underlayment.

Figure 4 shows a 150-year-old slate roof being replaced in Boston. Although the roof was still functioning at the time of replacement, and the existing roof system, made of slate, 1" boards, 30 lb. felt, and nails, had demonstrated a 150 year performance, the contractors who replaced the roof completely abandoned the existing system and replaced it with one that had no proven longevity, emphasizing underlayment and completely eliminating any chance of air transpiration. The original 1" roof board deck, still sound, was covered with 1/2" plywood, then peel and stick, then 30 lb. felt, then slate. Will this new roof system last 150 years? Time will tell, but why reinvent the wheel? A chain is only as strong as its weakest link. Traditional slate roofing systems have already proven themselves, are less expensive, are more environmentally friendly, and take less time to install. If one wants to guarantee that a slate roof will last a century or two, traditional methodologies should be followed.

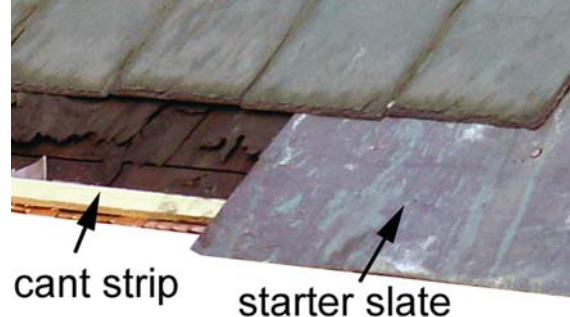
Figure 7 (above): Note that the starter slate is laid back-side-up and is propped up by a cant strip.

Often, the cant or shim strip is missing underneath the starter course. Starter slates must be angled on the roof in order to match the angle of all the other slates in the field of the roof (Figure 6). Typically, this was done by installing a wood strip (Figure 7), but it can also be achieved by using a metal drip edge with a cant formed into the metal, or even by raising the fascia.

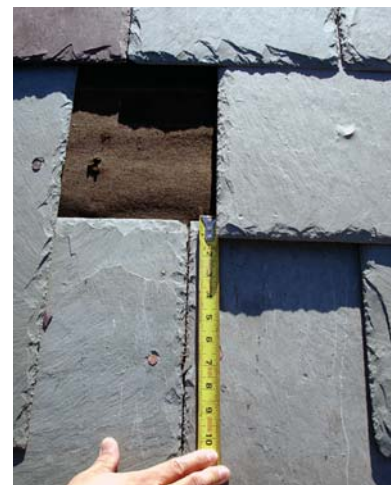
Figure 10 (right): This is an example of inadequate headlap (about 1") on a shopping center in Louisiana. There is no solution for this poorly installed new slate roof other than to remove it and start over.

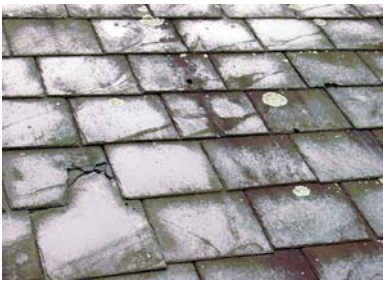
Figure 13 (above): Each course of slates should have been staggered so as to break the course below down the center. Instead, these slates were butted directly over the underlying slating nails, ensuring leakage.

**9) WATCH YOUR LATERAL OVERLAPS:** Lateral overlaps, or sidelaps, should also be 3" minimum. However, don't be surprised to see slates with no lateral overlap at all, as shown on an historic building in Georgia (Figure 12). Incorrectly placed sidelaps can leave the butt-joint directly over the slating nails, as shown on an historic Pennsylvania State Park building in Figure 13. This will allow direct water entry through the nail holes.

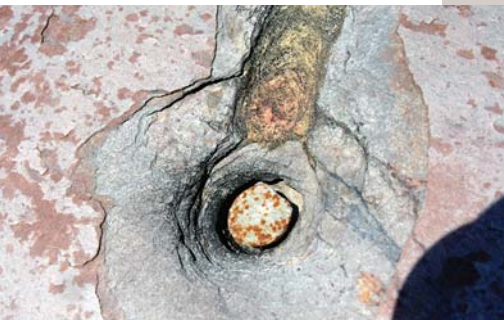
Figure 15: A protruding nail head eventually wears a hole in the overlying slate.

**10) AVOID OVER-NAILING AND UNDER-NAILING:** Another common installation mistake is the overnailing and undernailing of the slates. Slate nail holes are meant to be crater-shaped to allow the nail head to sit down inside the slate (Figure 14). Otherwise, the nail head will protrude above the slate and rub against the overlying slate, eventually creating a hole (Figure 15). When the nail isn't driven far enough, this is known as undernailing. Overnailing, on the other hand, is when the nail is driven too far and breaks through the slate. This leaves the slate hanging on one nail or sliding out altogether (Figure 16).

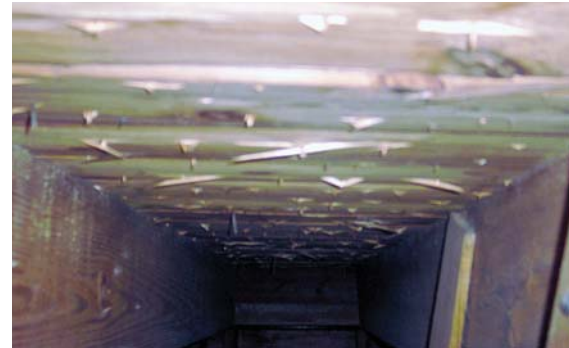
Figure 17: When the slating nails are too long, the back of the roof decking breaks out. This reduces the effective holding power of the nail. A longer nail, therefore, does not mean more holding power. The best nail length just barely penetrates the roof deck, if it penetrates at all.

**11) USE THE RIGHT NAIL LENGTH:** Nail length is an issue that is commonly off the radar screen of the average roofing contractor. The slating nails should barely penetrate the roof deck boards. If the nails are too long, they break through the back of the boards and splinter out the wood, reducing the board thickness where

the nail is located and undermining the effective holding power of the nail (Figure 17).

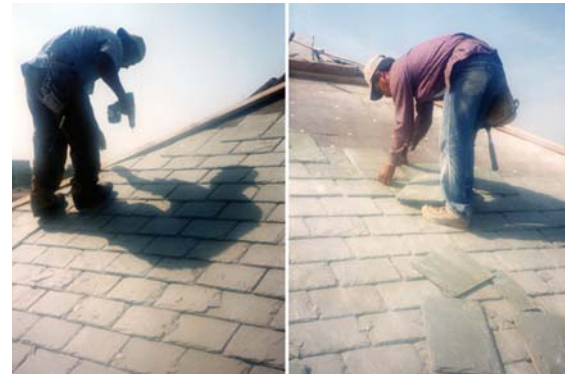
Figure 18: It is a mistake to walk on a slate roof during installation.

new slate roof installations is what I call the Bigfoot Syndrome — roofers walking on the slates during installation, as shown in Figure 18 on a new bank building in Kansas. An experienced slating crew will make every effort to keep off the slates during installation by staging the roof correctly (Figure 19). When Bigfoot walks all over the slates, the shingles

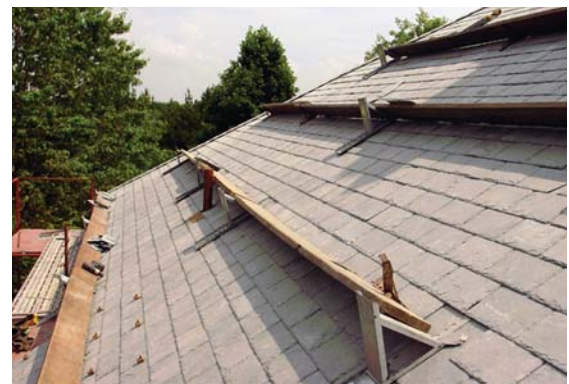
Figure 19: A correctly-staged slate roof will enable the roofers to install the slate without the need to walk on the shingles.

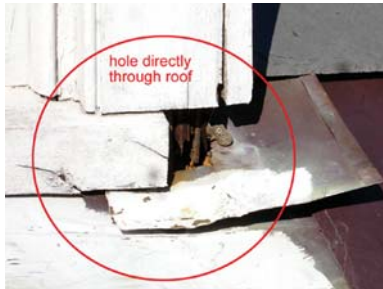
Figure 24 (above): This is a case where the corner flashing is neither folded nor soldered, leaving a large hole in the roof.

**13) INSTALL FLASHING CORRECTLY:** Flashings provide all sorts of opportunities for error. Negative overlap, for example, is sure to leak. Figure 21 provides an example of negative flashing overlap. Uphill flashing should always lap on top of downhill flashing. When lower flashings lap on top of higher flashings, water can enter the roof. Corner joints on roof penetrations are also commonly flashed incorrectly — chimneys provide a perfect example. The corner flashings must either be correctly folded, or else soldered in order to prevent leakage there. If a corner isn't folded or soldered, as shown in Figure 22, then the only thing keeping it from leaking would be caulk or sealant, which does not have adequate longevity. An incorrectly folded chimney corner is illustrated in Figure 23. This is a leak waiting to happen. Dormers also often have corners that need to be flashed. Without the knowledge of folding corners or soldering, a dormer corner can be left wide open and waiting for the first good rainstorm (Figure 24).

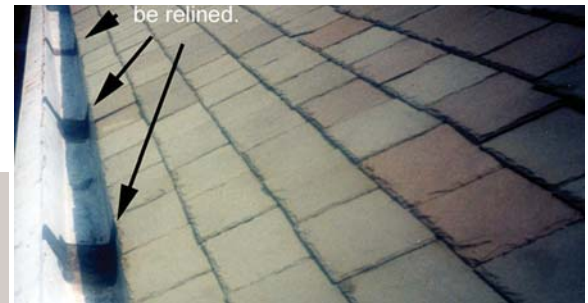
Figure 25 (above): Box gutters require expansion joints, otherwise the solder joints will crack under pressure. This is evident by solder joints that have been covered by roof cement, a common sight on box gutters, new and old.

**14) ALLOW FOR METAL EXPANSION:** Common on many slate roofs are built-in gutter systems. "Box gutters" require expansion joints, but they're often installed without any allowance for expansion whatsoever. This becomes evident by the failure of the solder joints (Figure 27), which are often roof-cemented after they start leaking in order to alleviate water penetration (Figure 25). Expansion joints (Figure 26) can be added after the gutters are installed, but it's a lot easier to install them correctly in the first place. Read more about expansion joints in TR 6 ([traditionalroofing.com](http://traditionalroofing.com)).

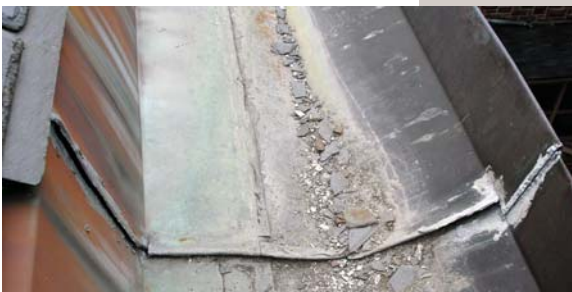
Figure 27: This is a perfect example of a new built-in gutter showing failed solder joints because not a single expansion joint was installed in the gutter system.

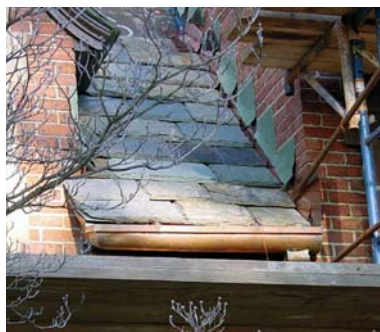
Figure 31: This gutter is just waiting for a snow avalanche to knock it off.

**ROOF:** Speaking of gutters, they're often hung too high. The outer edge of external gutters should be below the plane of the roof (Figure 30) in locations where snow or ice could slide down the roof and knock them off. The gutter in Figure 31, for example, will not last long.

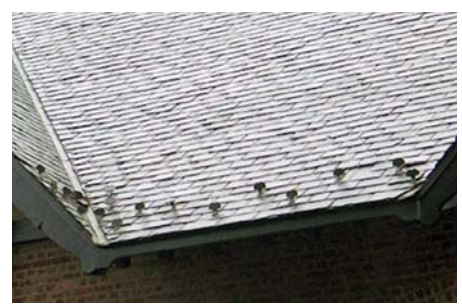
Figure 32: Snowguards must be installed in adequate quantities, or else they will get knocked off in the first bad ice storm and will damage the roof in the process.

**19) USE ENOUGH SNOW GUARDS:** Snow retention systems are another source of problems when they're installed incorrectly. One of the tricks for a proper snowguard installation is to use enough of them. Otherwise, they won't be able to hold the weight of the ice and snow and will rip out, taking slates with them. A poor snowguard installation is shown in Figure 32. The lack of snowguards on this large roof caused many to rip out during an icy winter. Follow the manufacturer's guidelines when installing these popular slate roof elements.

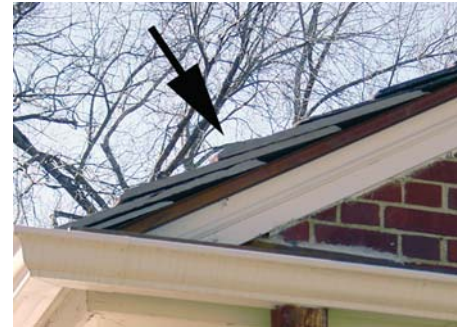
Figure 33: Diamond blades cut a square edge on slates, making them stick out like a sore thumb.

**20) USE THE CORRECT TOOLS:** Incorrect tools can be the downfall of many a would-be slater. Slate roofing has its own unique set of tools and equipment. For example, slates should be cut with, you guessed it — "slate cutters." A slate cutter will leave a beveled edge on the shingle, allowing it to match all the other shingles on the roof, all of which have beveled edges. If a diamond blade is used to cut the slates, a square edge remains, which can stick out like a sore thumb and get a roofer into trouble if the property owner doesn't like the look of it. Figure 33 is a perfect example of square edges exposed at the wrong place on a slate roof. These square edges could be dressed with a slate hammer and stake to give them the proper appearance, but one has to first have these tools in the tool box. When the proper cutter is not on hand, a roofer will resort to drastic measures to try to cut slates, as shown in Figure 34, where it looks like the slates were chewed off by Bigfoot himself. This brand new roof, by the way, also had to be completely removed and reslated, causing the property owner much expense and grief.

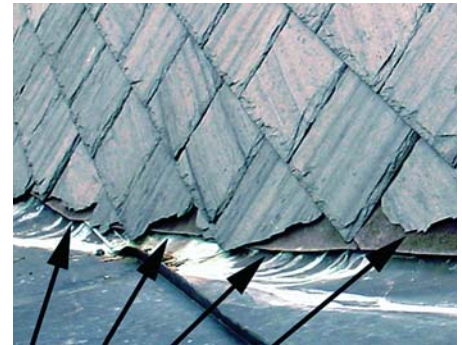
Figure 34: Slate roofing requires the correct tools to do the job right. There is no excuse for the sort of work shown above.
